UNITED STATES ENVIRONMENTAL PROTECTION AGENCY

SUBJECT: ACTION MEMORANDUM - \$2 Million Exemption Request for an  
Emergency Removal Action at the Harrison Sheet Steel  
Site, Chicago, Cook County, Illinois  
(Site ID# OP)

**ATTACHMENT 3  
HARRISON SHEET STEEL SITE  
PHOTOGRAPHS**

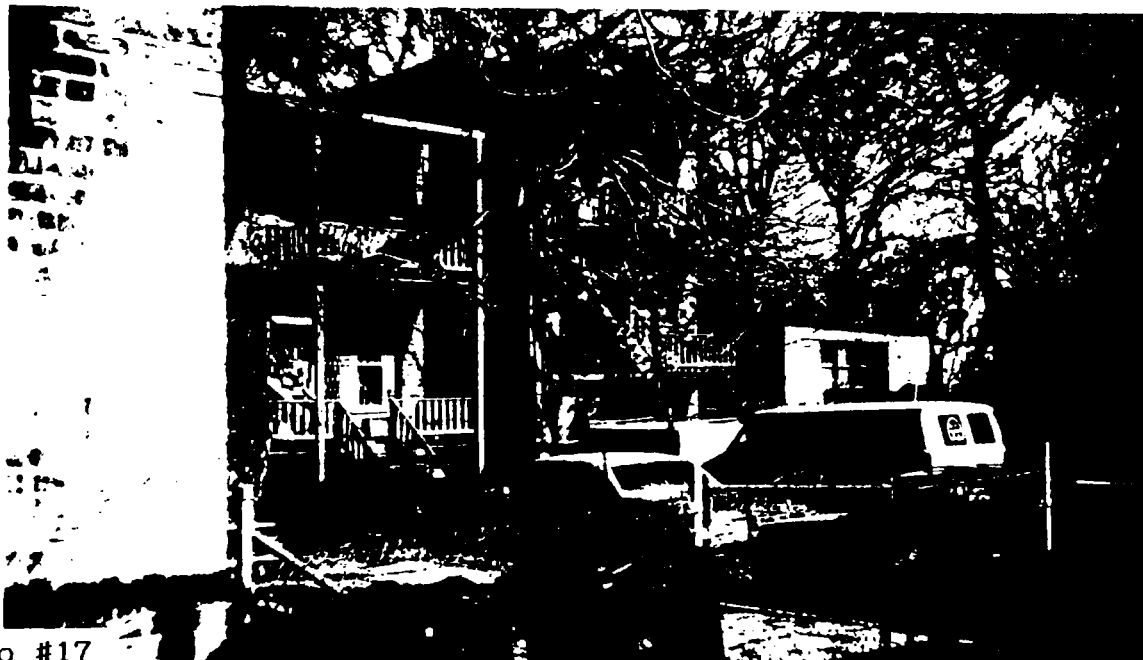
Photo #17

Description: Closer view of homes located immediately behind the HSS site.
